PHASE II

**FIRE RESISTANCE TESTING OF
BULKHEAD AND DECK PENETRATIONS**

**Final Report
December 1988**

| 1. Report No. CG-M-3-89 | | 2. Government Accession No. | | 3. Recipient's Catalog No. | |

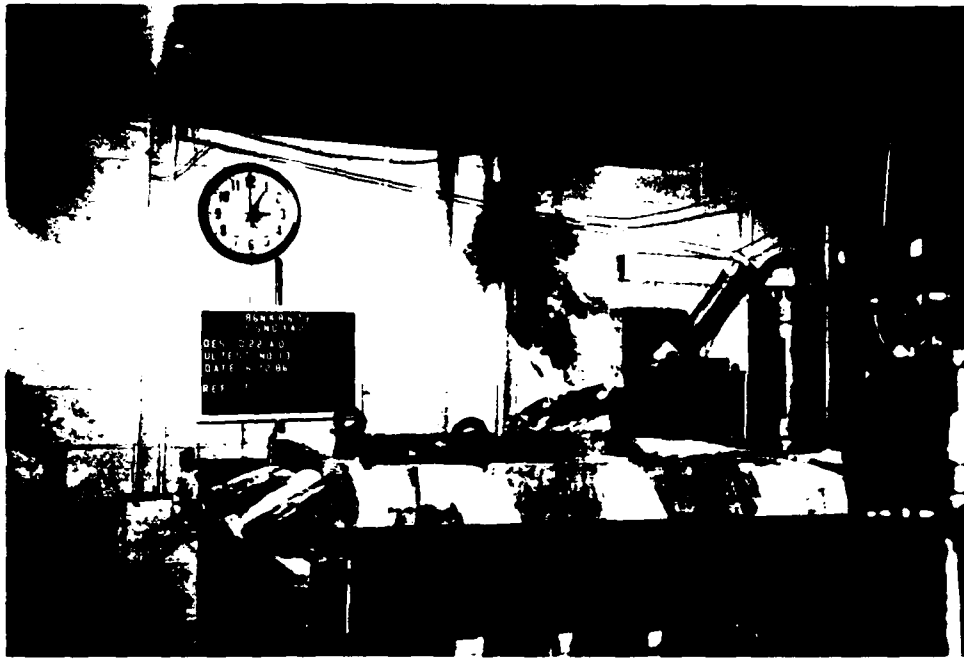
D22/A-O (Single Electrical Cable)

FIGURE 9. Class A-O Test Failures

smoke and was heavily charred. The cable jacket burst into flames at fifty-nine minutes. At the conclusion of the one hour fire test, a hose stream test was conducted. The single electrical cable penetration D24/A-0 began to issue smoke from the interface of the cable and the steel pipe at six minutes into the test. At forty minutes, the smoke intensity increased and the cable began to deteriorate badly. The hose stream test was conducted since the electrical cable did not collapse into the furnace.

The test data in Appendix C indicate the presence of smoke on the non-fire side of the Class A-0 penetrations D10/A-0, D14/A-0, D22/A-0, D23/A-0, and D24/A-0. A review of the photographic documentation indicates that only penetrations D22/A-0 and D24/A-0 appeared to pass smoke through the penetrant. Based on interpretation of photographic evidence, the occurrence of smoke on the non-fire side of penetrations D10/A-0, D14/A-0 and D23/A-0 was determined to be the result of moisture being driven from the sample, contaminant oils smoldering on the penetrant's non-fire side, off-gassing of the fiberglass used to seal the steel plate to the furnace top, and smoke coming from under the steel plate assembly where it was not sealed securely to the top of the furnace. It appeared that no smoke actually passed through the penetrants in any of these three tests.

Three single electrical cable penetrations (D22/A-0, D23/A-0, and D24/A-0) were tested for a Class A-0 rating. The brass terminal tube used in each of these penetrations was missing an o-ring fitting. Fire retardant oakum was substituted for the missing o-ring. Only sample D23/A-0 passed the Class A-0 test. Figure 13 shows that the three electrical cable penetrations had similar temperature readings at the 4-inch (10.2 cm) height above the steel plate but the penetrant which passed the Class A-0 test reached a temperature of 369°F (187.2°C) after 60 minutes at the 16-inch (40.6 cm) height, compared to temperatures of over 600°F (315.6°C) after 60 minutes at similar heights on the two penetrants which failed the Class A-0 test.

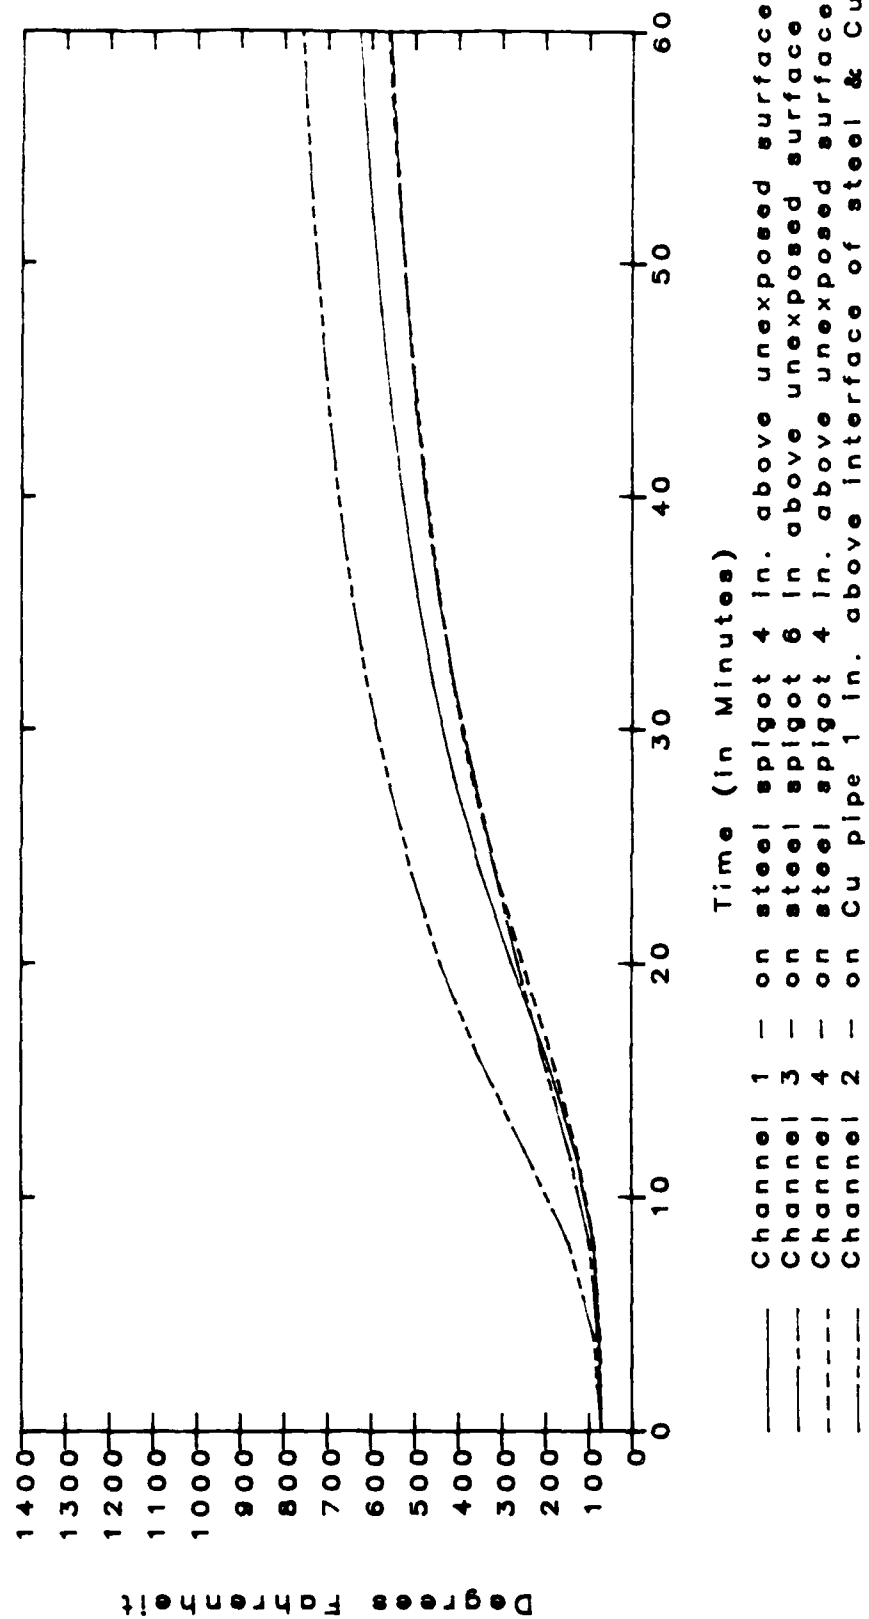
SAMPLE D10/A0

The copper penetration D10/A-0 passed the Class A-0 fire exposure test. Figure 10 shows three temperature plots for different heights on the steel spigot enclosing the copper pipe and one temperature plot for the copper pipe one inch (2.5 cm) above the steel spigot. This figure shows that after fifteen minutes into the test the copper pipe at a one-inch (2.5 cm) height above the spigot remained over 125°F (69.4°C) hotter than the spigot throughout the test.

FIGURE 10. Temperatures on Copper Penetrant (D10/A-O) During Class A-O Test

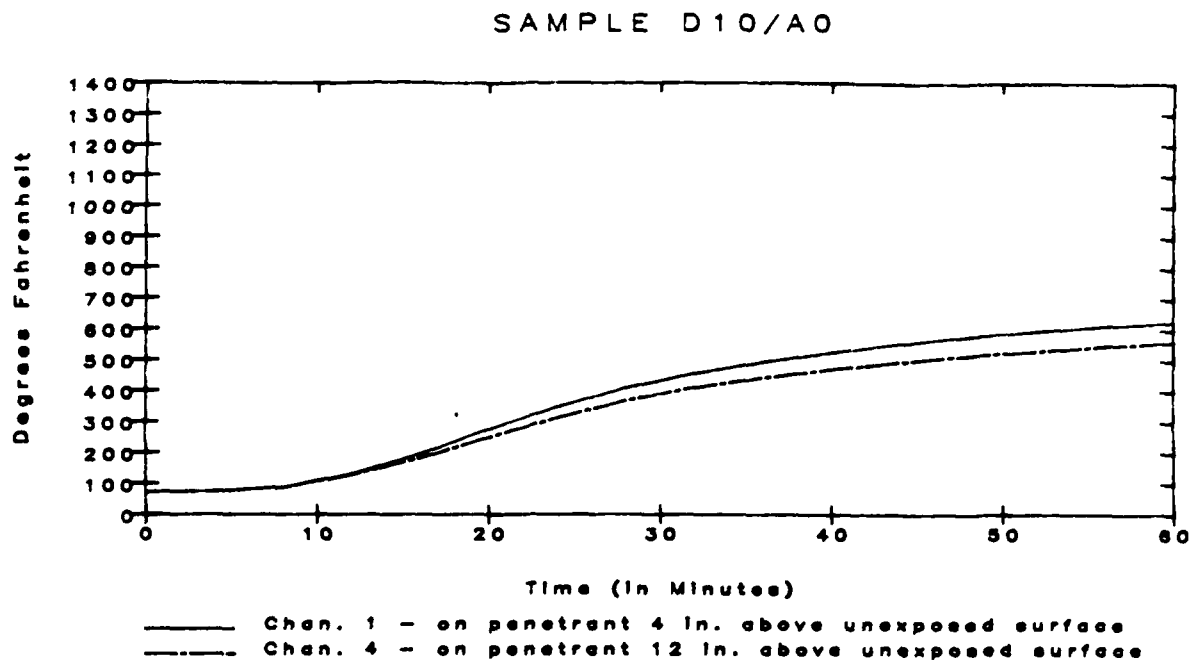
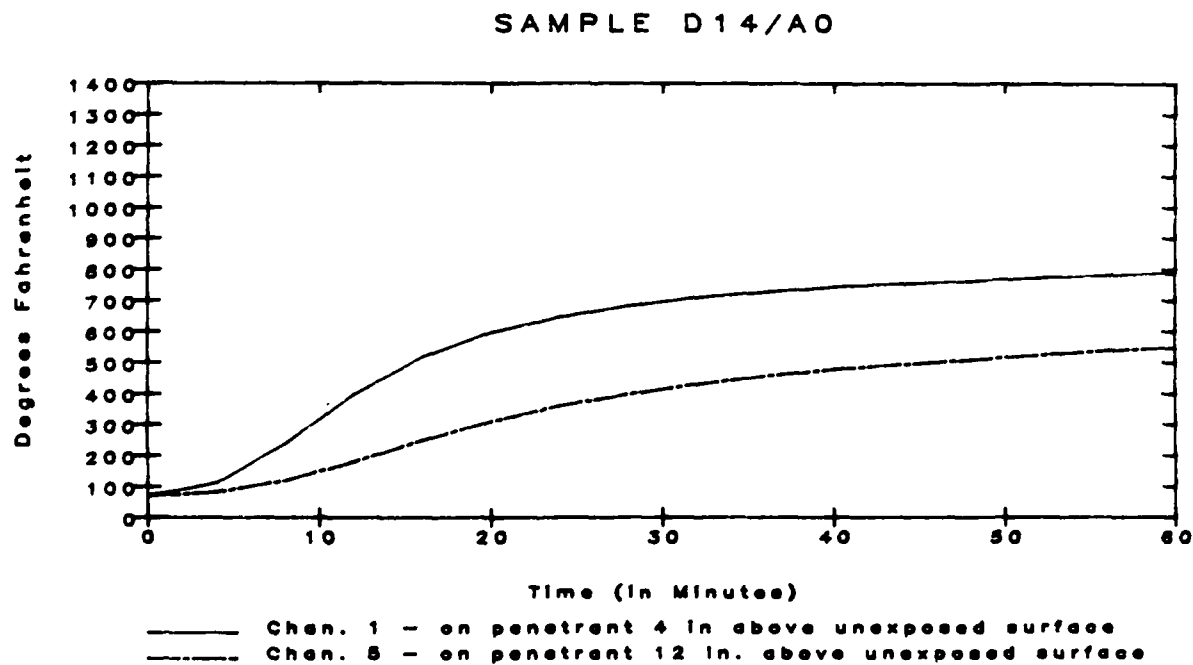
The PVC penetration threaded to a steel spigot (D14/A-0) passed the Class A-0 fire exposure test. Observations recorded in the Appendix C data sheet for this sample indicated the presence of smoke on its non-fire side, but a review of the photographic documentation clearly indicated that the smoke did not come through the penetrant, but rather from around the edges of the steel plate assembly where it lay on top of the furnace. It is interesting to note that the temperatures (Figure 10) recorded at the 12-inch (30.5 cm) height on the PVC penetrant (D14/A-0) and the copper penetrant (D10/A-0) were similar, while temperatures recorded at the 4-inch (10.2 cm) height were over 160°F (71.1°C) higher on the PVC penetrant. Both these penetrations had a steel spigot on which these temperatures were measured. The interesting point is that the steel spigot threaded to a PVC pipe was the hottest at a 12-inch (30.5 cm) height, while a steel spigot with a copper pipe through it was cooler at this same height. It appears that the copper pipe inside the steel spigot acts as a heat sink as the distance increases from the steel plate.

It is also interesting to note that the temperatures at a 12-inch (30.5 cm) height on a steel spigot threaded to a PVC penetrant (D4/A-0) and on a steel spigot with a continuous copper pipe through it were similar (Figure 11), whereas temperatures recorded at a 4-inch (10.2 cm) height on both steel spigots were over 160°F (88.9°C) hotter on the spigot with the PVC pipe. It appears that the copper pipe inside the steel spigot acts as a heat sink as the distance increases from the steel plate.

FIGURE 11. Temperatures on PVC Penetrant (D14/A-O) and Copper Penetrant (D10/A-O) During Class A-O Test

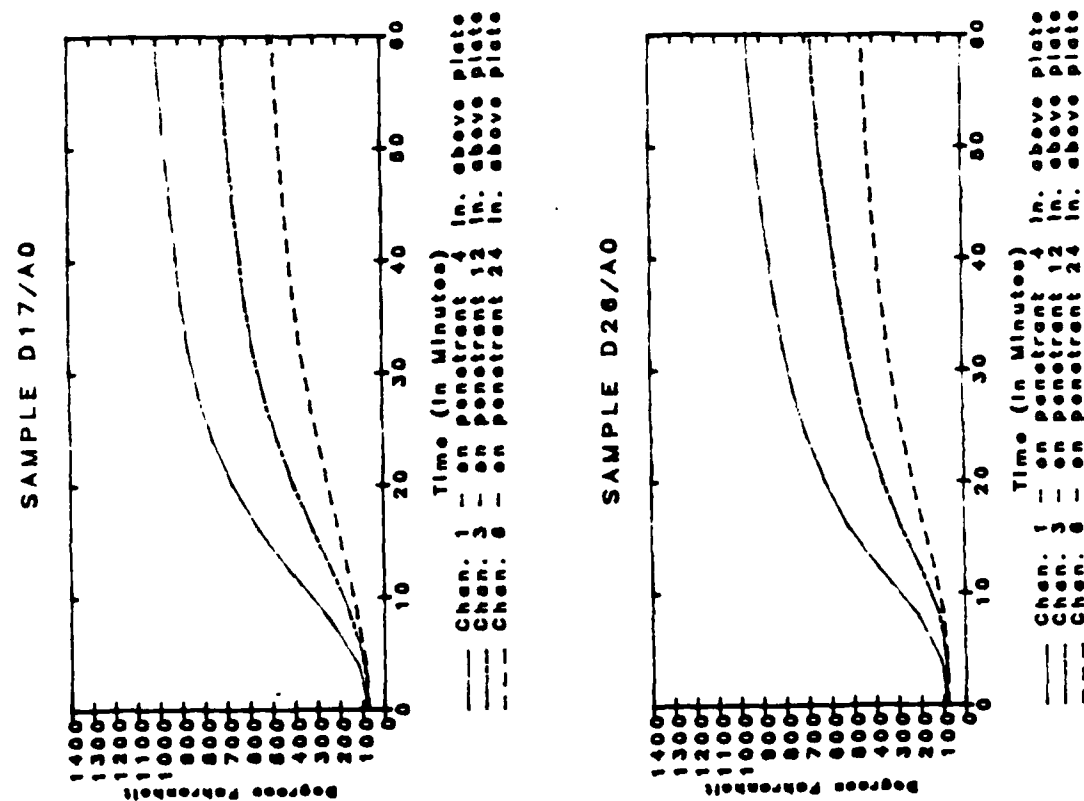
Three ventilation duct penetration types (D17/A-0, D25/A-0, and D/26A-0) were tested for a Class A-0 rating. Each penetration passed the fire exposure test. Each penetrant had a 6-inch (15.2 cm) steel spigot on the fire side and a 30-inch (76.2 cm) steel spigot on the non-fire side. Figure 12 shows temperature plots at a 4-inch (10.2 cm), 12-inch (30.5 cm), and 24-inch (61.0 cm) height on the three penetrants. The temperature plots are similar at the same heights for the three penetrants. A comparison of the temperature plots in Figure 11 and Figure 12 show that temperatures at the 4-inch (10.2 cm) and 12-inch (30.5 cm) height on the ventilation duct penetrants are at least 150°F (83.3°C) hotter than similar heights on the PVC penetrant and the copper penetrant.

FIGURE 12. Temperatures on Ventilation Ducts (D17/A-O, D25/A-O, D26/A-O) During Class A-O Tests

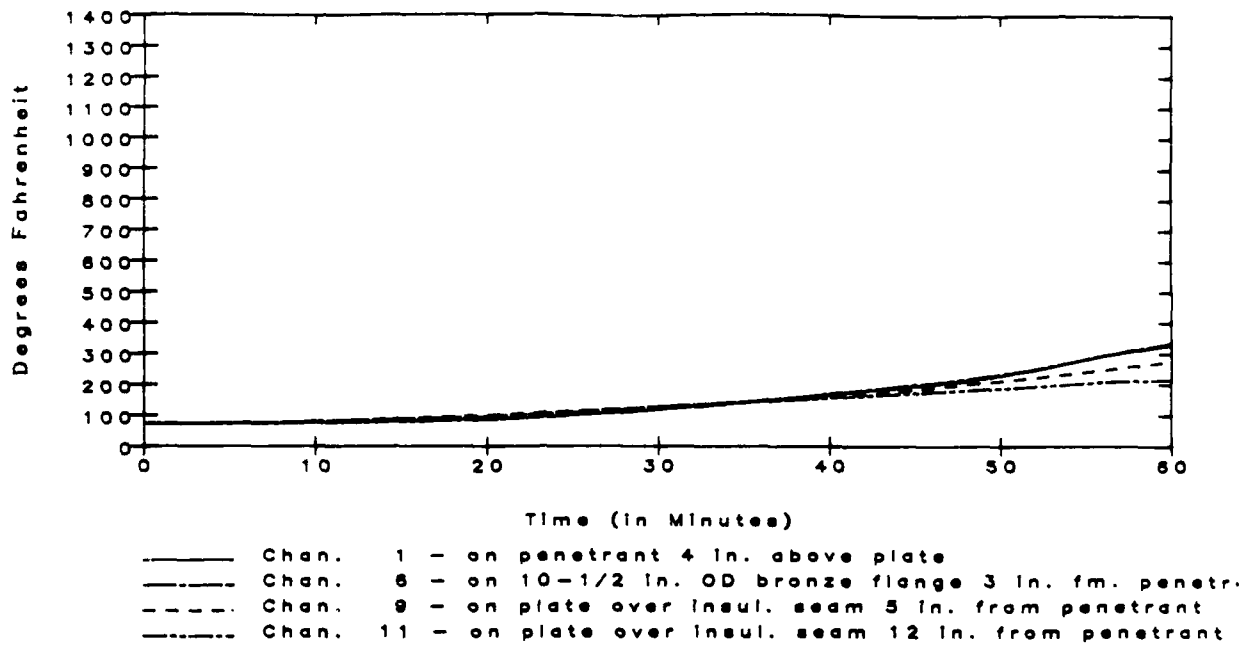
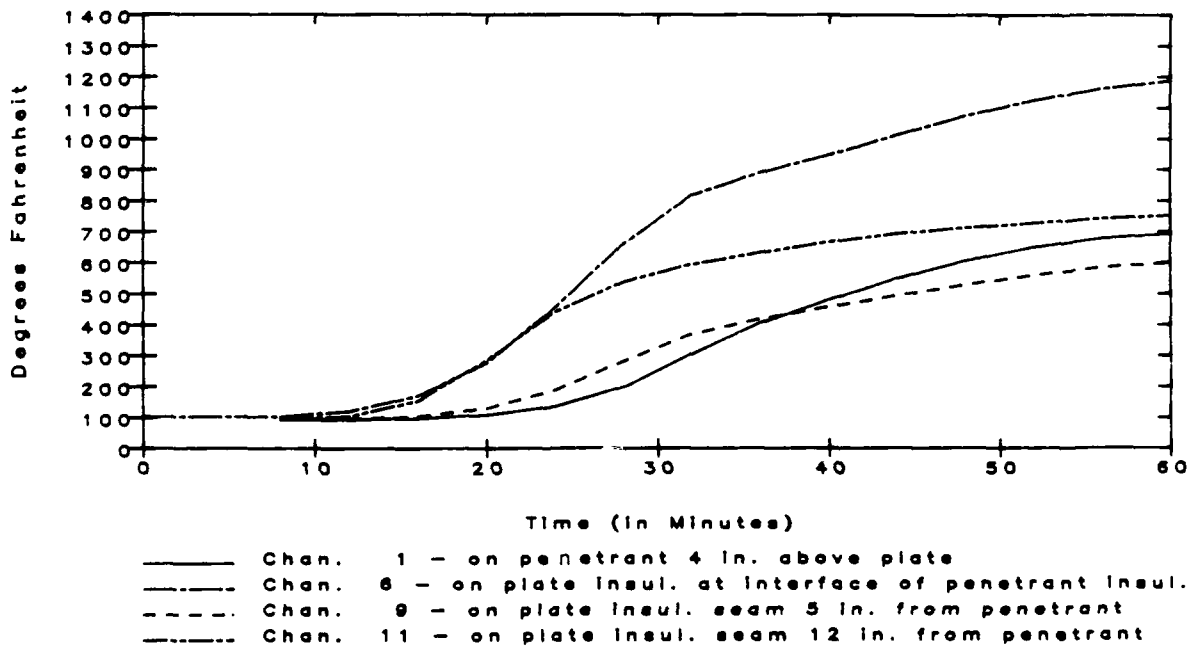
Eight copper penetrations were insulated and tested. Two penetrations were insulated on the fire side and passed the requirements for a Class A-60 rating. Six penetrations were insulated on the non-fire side and failed the heat transmission test for a Class A-60 rating. Figures 15, 16, and 17 show temperatures above the acceptable temperature rise limits for the six penetrations which failed. These failure temperatures occurred on both the penetrant insulation and on the steel plate insulation for the six penetrations. Figure 18 shows the temperature plots for two copper penetrations which are identical in construction except that one sample is insulated on the fire side and the other sample is insulated on the non-fire side. Figure 19 shows the same arrangement for another pair of identical copper penetrations. In these two figures, the temperature plots show that the penetrations insulated on the non-fire side failed to meet the temperature rise requirement, while temperature plots at identical locations on the penetrations insulated on the fire side show these penetrations met this requirement. This points out the value of insulating the fire side to provide a greater degree of protection against temperature rise.

FIGURE 18. Temperatures on Copper Penetrations (D4/A-60E, D4/A-60U) During Class A-60 Test

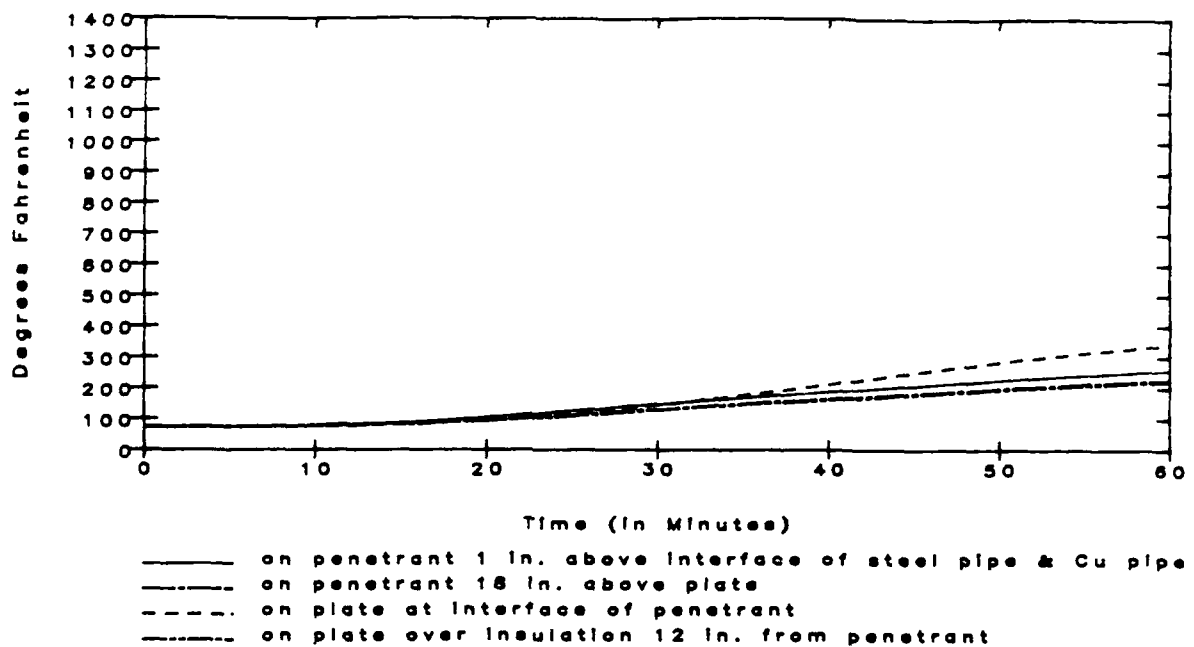
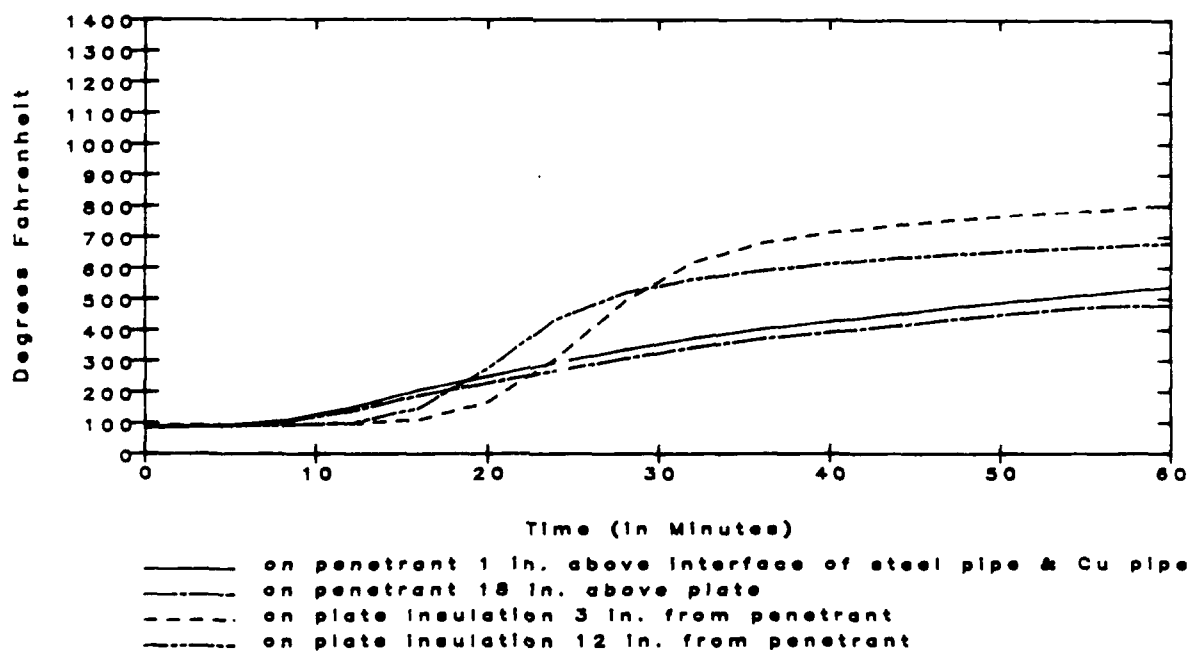
FIGURE 19. Temperatures on Copper Penetrations (D10/A-60E, D10/A-60U) During Class A-60 Test

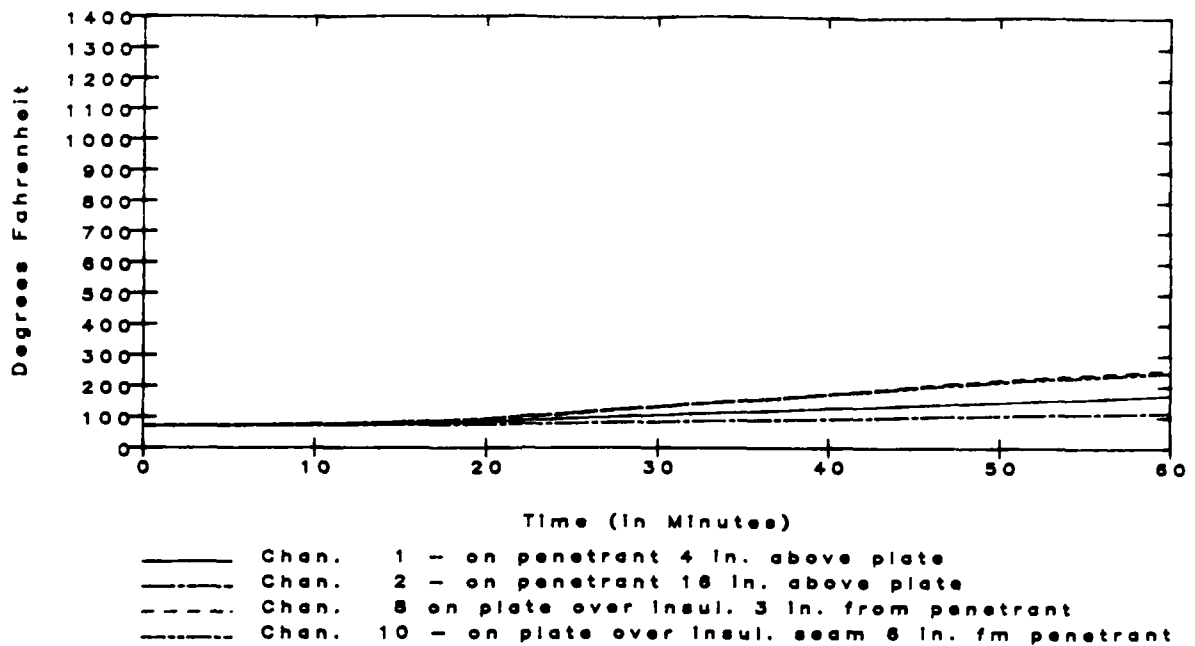
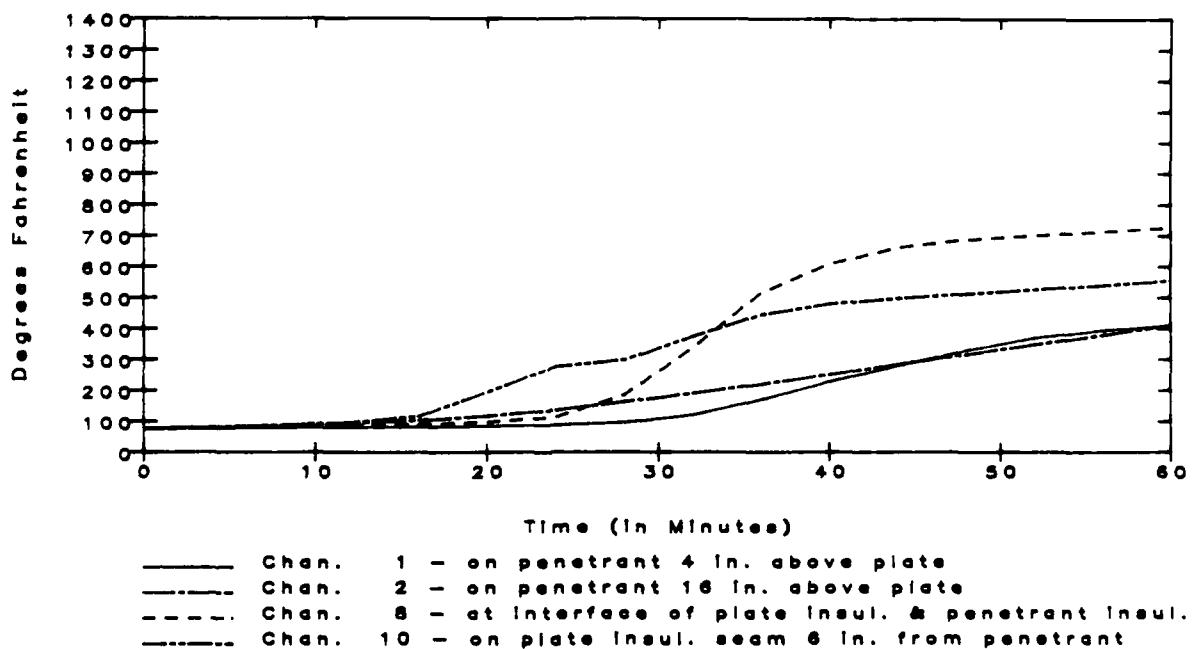
Four PVC penetrations were tested for a Class A-60 rating. Three of the penetrations were insulated on the non-fire side and failed the temperature rise requirement for a Class A-60 rating. The temperature plots in Figure 20 show that the temperature limits were exceeded for these three penetrations on both the penetrant insulation and the steel plate insulation. One penetration was insulated on the fire side and passed the test requirements for a Class A-60 rating. Figure 21 shows the temperature plots for two PVC penetrations which are identical in construction except that one sample is insulated on the fire side and the other sample is insulated on the non-fire side. The temperature plots show that the penetration insulated on the fire side passed the temperature requirement while the sample insulated on the non-fire side failed. Again, this indicates

FIGURE 21. Temperatures on PVC Penetration (D14/A-60E, D14/A-60U) During Class A-60 Test

that insulating the fire side provides a greater degree of protection against excessive heat transmission.

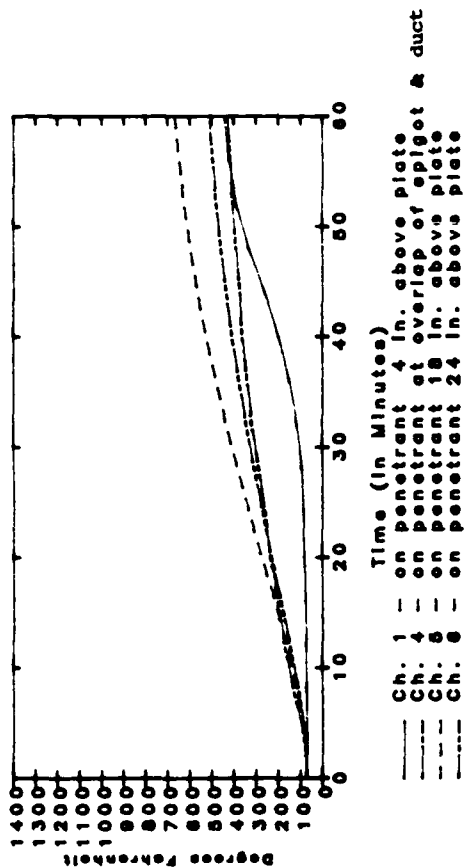
SAMPLE D17/A60U

Six ventilation duct penetrations, two each of three different types, were tested. Three penetrations (one each of the three different types) were insulated on the non-fire side and the remaining three penetrations were insulated on the fire side. All six penetrations failed the temperature requirements for a Class A-60 rating. The temperature plots in Figure 22 show that the temperature rise for the three penetrations insulated on the non-fire side was above the acceptable limits for a Class A-60 rating. The temperature plots in Figure 23 show that the temperature rise for the three penetrations insulated on the fire side was above the acceptable limit for a Class A-60 rating. The test data in Appendix C for these six penetrations shows that the three penetrations insulated on the non-fire side failed the temperature requirements on both the penetrant insulation and deck plate insulation. Only two of the penetrations insulated on the fire side failed to meet the temperature requirements on the penetrant insulation and deck plate insulation whereas, the third penetration failed the temperature requirements on just the penetrant insulation.

FIGURE 22. Temperatures on Ventilation Duct Failures (D17/A-60U, D25/A-60U, D26/A-60U) During Class A-60 Test

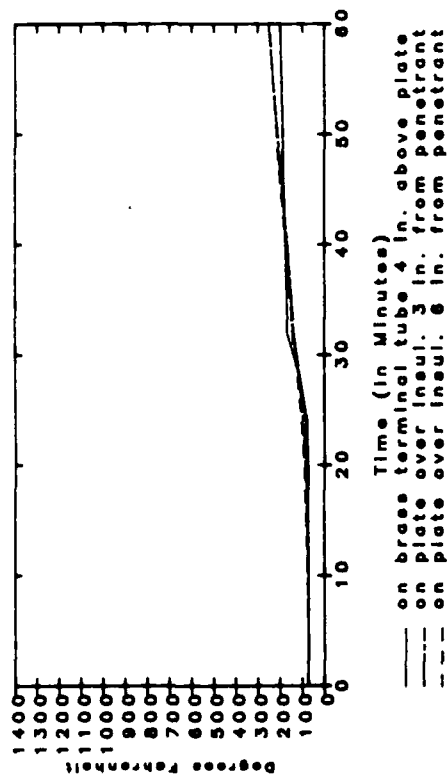
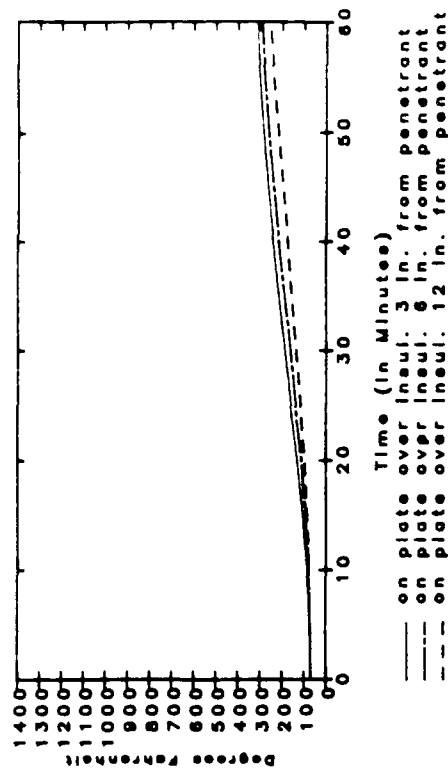
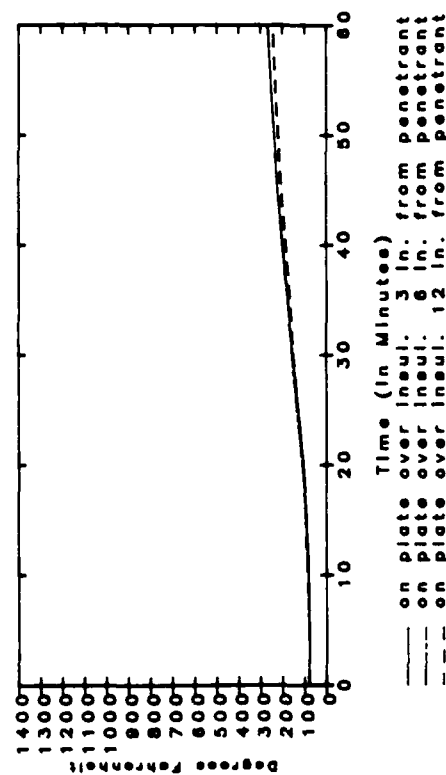
Eleven electrical cable penetrations were tested. The brass terminal tube used in seven of these penetrations was missing its interior o-ring fitting. Fire retardant oakum was used in place of the missing o-rings. Five of the penetrations were insulated on the non-fire side, three were insulated on the exposed fire side, and three were only partially insulated on the test plate. The temperature plots in Figures 24 and 25 show that the temperature requirements for a Class A-60 rating were exceeded for the five penetrations insulated on the non-fire side. The three penetrants insulated on the fire side passed the temperature requirements for a Class A-60 rating, but two of the penetrants (D23/A-60E and D24/A60E) did fail the additional requirement of preventing the passage of smoke. The three penetrations partially insulated over either one side or both sides of the steel plate failed the temperature requirements for a Class A-60 rating. The penetrations represented in Figures 25 and 26 are identical in construction and differ only in the location of the insulation. It is interesting to note that the three penetrations in Figure 26 were insulated on the fire side and passed the temperature requirements for a Class A-60 rating, whereas the five penetrations in Figure 25 were insulated on the non-fire side and failed the temperature requirements for this rating. Figure 27 shows the temperature plots at three heights on cables in the three partially insulated penetrations. This figure shows that the penetration sample D19/A-60-3E & 3U, insulated on both sides of the steel plate, provided the lowest temperatures at a 6-inch (15.2 cm) height on the cables whereas the penetration sample D19/A-60-6U, insulated on the non-fire side, provided the highest temperatures at the 6-inch (15.2 cm) height on the cables.

FIGURE 26. Temperatures on Electrical Cables Passing the Class A-60 Test

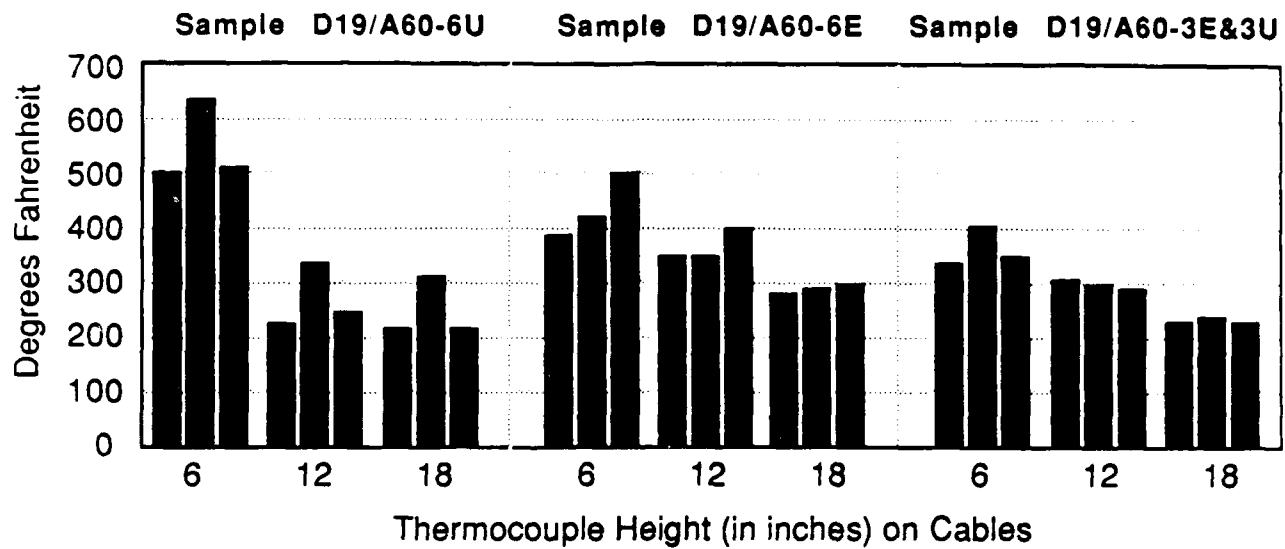
Results in Table 1 show that all eighteen penetrations insulated on the non-fire side failed to meet the temperature rise requirements for a Class A-60 rating, while only three of the nine penetrations insulated on the fire side failed to meet those requirements temperature rise test for a Class A-60 rating. The three penetrations with partially insulated steel plates also failed to meet the temperature rise requirements for a Class A-60 rating.

FIGURE 27. Temperatures on Partially Insulated Penetrations
